DEPARTMENT OF SUPPLY
AUSTRALIAN DEFENCE SCIENTIFIC SERVICE
AERONAUTICAL RESEARCH LABORATORIES

Instruments Technical Memorandum 44

VIBRATION TESTS
ON
MALKARA J-3 GYROSCOPE

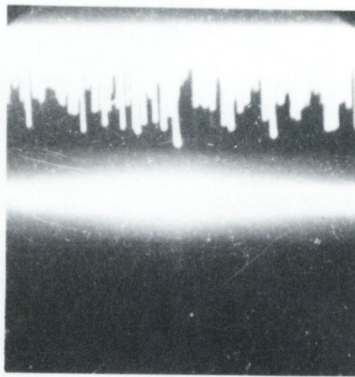
FIG. 7[b] ACCEL. = 2g

← WIPER LIFT CLEARLY EVIDENT

WIPER AND CENTRE CONTACT LIFT FOR ROTOR UNCAGED

The photographs of Fig. 6 show that lift of the wiper for the rotor caged condition, was greater at 2 g and 3 g than at higher g's, a fact that could not be explained. For the rotor uncaged, lift of the wiper was clearly evident at loads of 2 g and above (Refer to Fig. 7). For both caged and uncaged rotor conditions, centre contact lift only became evident at the higher g loads. In general the photographs of Figs. 6 and 7 revealed that lift of both the wiper and centre contact was much more pronounced for the uncaged rotor case, and that centre contact lift was much less than wiper lift.
